River water quality deterioration admits the booming export flower business in the Pisque watershed in Ecuador

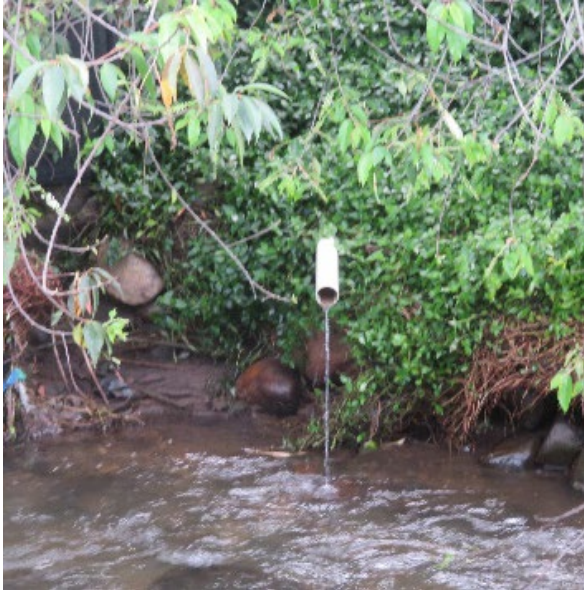
small animals can be caught with a simple net, detected by the naked eye, and give an indication of the water quality. The results were appalling: upstream of the villages and greenhouses the water was crystal clear and drinkable, downstream very little macro invertebrates were found, implying a ‘dead’ river (see map and Table 1).
